GEOLOGICA
International Journal of Earth Sciences

Assessing The Impact Of The Main Boundary Thrust On Landslide Dynamics: Insights From The Western Limb

Simon Sadiq^{*1}, Muhammad Ali², Hasan Ali³, Adnan Alam Awan⁴

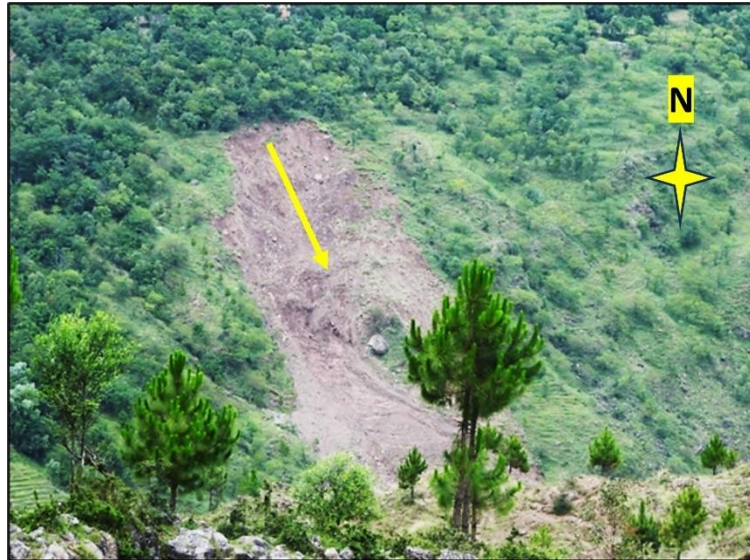
Figure 9: Nammal-IV landslide, just opposite to the Nammal-II landslide.

This landslide is situated just north of the Landslide-II, on the opposite side of the stream. Although this landslide was triggered in January 2020, a year before the trigger of the Landslide-II but its rate of progression has been lower than that of the Landslide-II. Its slope has an angle of 25° and faces SE direction. The houses are located at some distance from the landslide

crown, so there is no direct water infiltration from septic tanks/sewerage water. However, there is a spring at its crown which is a source of water infiltration into the landslide body. In the long run, the permanent infiltration due to spring water and domestic water on its upslopes may adversely affect the slope stability causing the possible re-activity of the landslide.

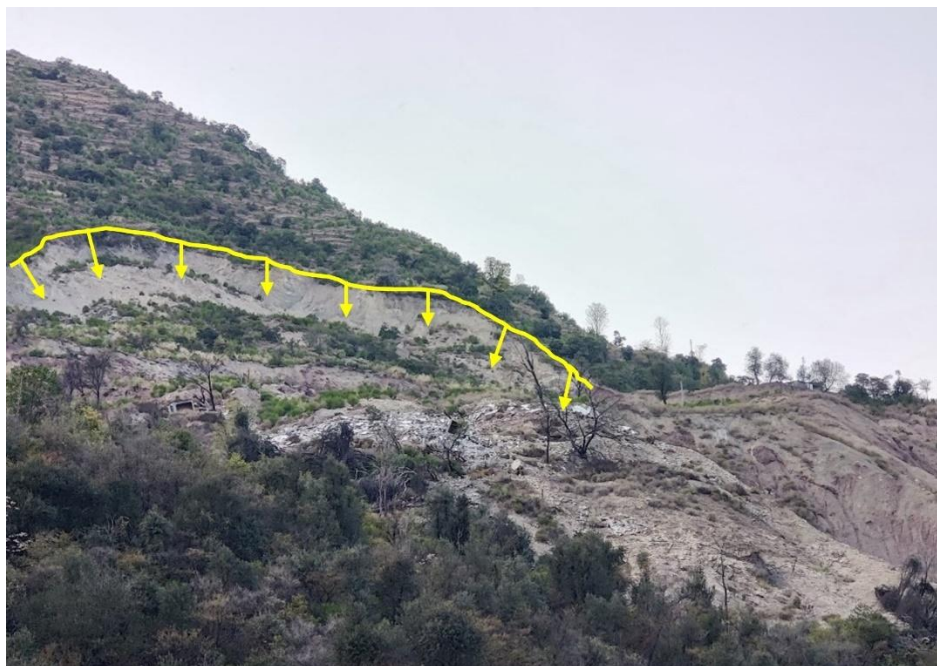
Figure 10: Crown of Domeshi Landslide located in the Hazara Formation.

The landslide is located on right bank of Jhelum River, opposite side of Muzaffarabad Kohala Road, near Domeshi village. The landslide event occurred by the start of August 2023 and its triggering factor was heavy rainfall just days before the event. The slow movement allowed the population for evacuation avoiding any life loss although ten houses were completely destroyed along with a metaled road and

agricultural land. This earth slide with surface area of $450 \times 250 \text{ m}^2$ has a slope angle of about 34° and faces towards SE direction. The fault line passes through the landslide body with its crown lying in the Hazara Formation and toe in the Murree Formation. Some water springs in the body of the landslide have stopped flowing after the slide. The slide material continues to move downslope in steps, slowly and gradually.

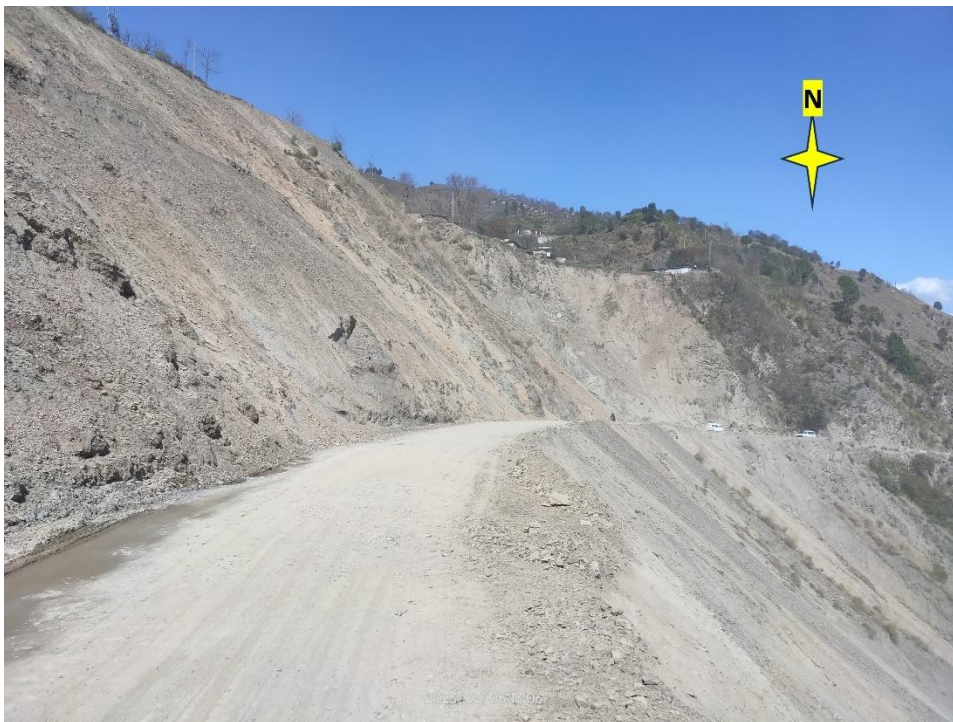
Figure 11: A view of Lohargali Landslide from Muzaffarabad-Garhi Habibullah Road.

Lohar Gali landslide is located near Lohar Gali village along Muzaffarabad Garhi Habibullah road. Here, the slope angle is 43° aspect is southeast. This landslide has been reported as more than 50 years old, as the exact date of initiation is not known. Although the slide remained partially active after the initial triggering but 2005 Kashmir Earthquake severely reactivated it. It occasionally blocks the road during rains. About eight houses have already been

relocated while another 20 are at risk. It is translational earth slide in slates of Hazara Formation; thinly laminated slates are crushed and highly weathered; dimension of the sliding zone was measured to be $270 \times 90 \text{ m}^2$. There are number of inducing factors: at first landslide triggered due to road cutting; secondly, MBT is also passing nearby whereas water infiltration/seepage from human settlements and agricultural lands has also been observed. Cracks are visible at the crown and the right flank.
